Gas Pipe Line Indonesia

Problem Definition

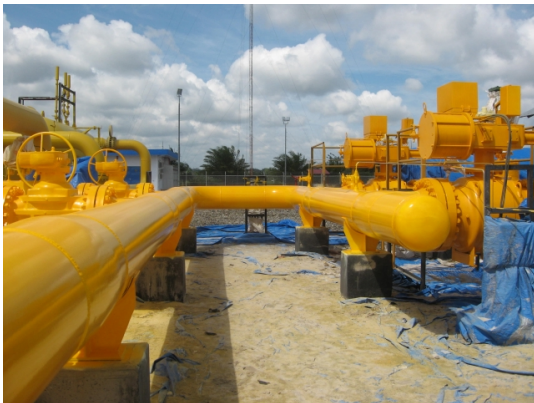
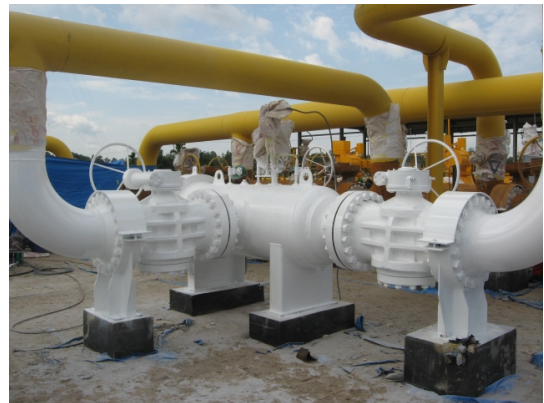
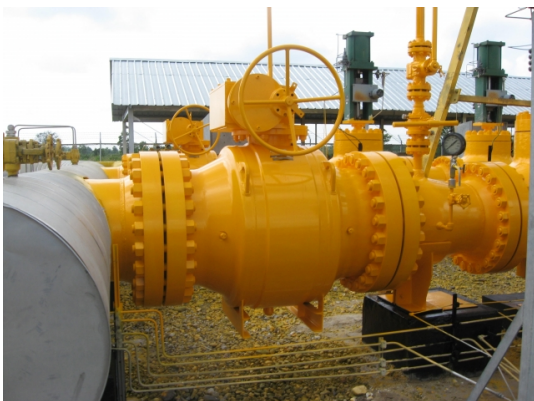
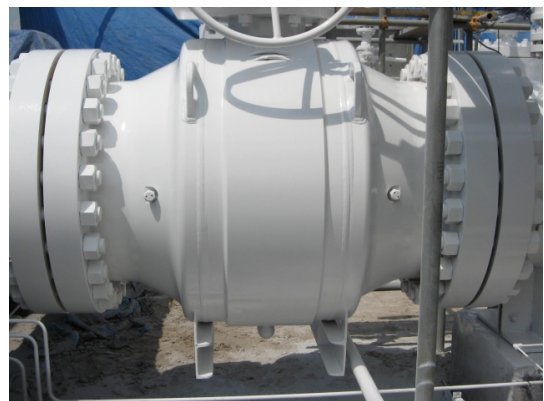
Project Pictures

A condensated gas pipeline needed maintenance. It was effected by corrosion. Due to the cold gas running through the pipe and the humid environment the pipe line was constantly condensated, which made conventional paints unusefull.

After sandblasting the pipeline, the old material and rust was removed. To tackle the condensation issue Moist Metal Grip was used as a base coat. For safety reasons the Moist Metal Grip was then coated with yellow tinted EnamoGrip. The trial was done at the pumping station. Treatment of the entire pipeline is dicussed and might proceed in 2009/2010. The results were extremely satisfying and no other products performed so well in the Tender. A big advantage was the application could be done Online. Please contact us for more information or pictures
