COT bv
Independent advice,
research and
management for
construction and
industry

Investigation of a HSC coating system on
thermal insulation and impact resistance

Project number : 20110411

Report number : LAB11-0972-RAP

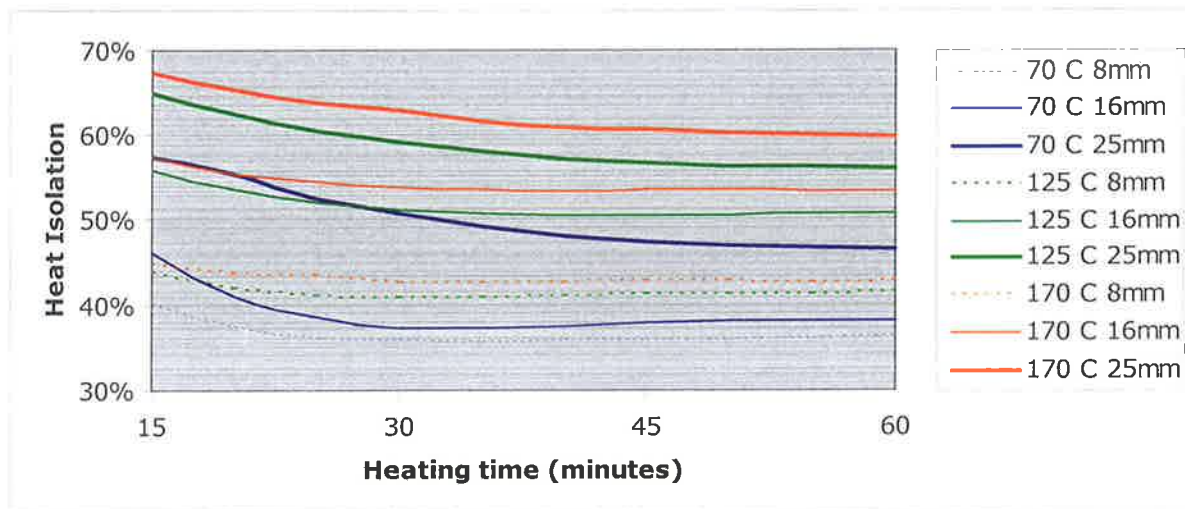
Figure 1: Graphical representation of thermal/heat isolation (% temperature reduction) for the 3 substrate temperatures (70, 125 and 170 °C) and the 3 isolation thicknesses (8, 16 en 25 mm) as a function of time (in minutes); data points in Tables 2-4

Figure 1 presents a graphical view of the data for the three substrate temperatures and the three isolation thicknesses.

Table 5 summarizes the data of the insulation tests and interprets it as a relative percentage temperature difference. All systems show about the same behavior: the relative temperature difference between top and bottom of the coating system increases with temperature. Also the relative temperature difference increases at one temperature with isolation thickness.

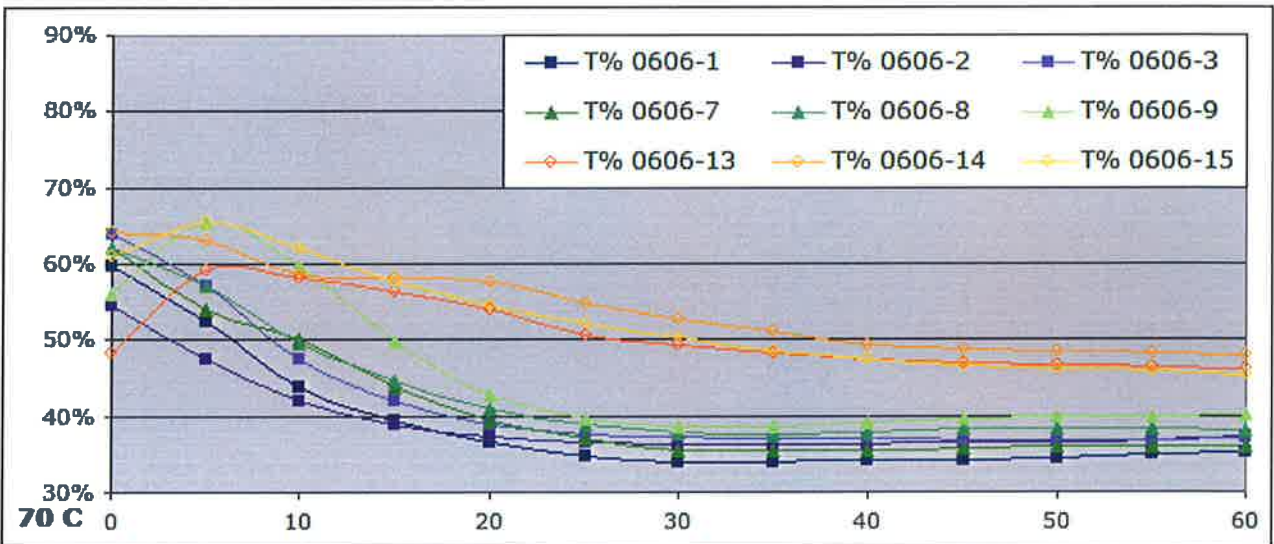
Percentage of **heat transmitted** through panel + coating at 3 panel temperatures and 3 coating thicknesses

70°C Time (min)	T%								
	0606-1	0606-2	0606-3	0606-7	0606-8	0606-9	0606-13	0606-14	0606-15
0	60%	54%	64%	62%	62%	56%	48%	64%	61%
5	52%	48%	57%	54%	57%	66%	59%	63%	65%
10	44%	42%	47%	50%	49%	60%	58%	59%	62%
15	39%	39%	42%	44%	45%	50%	56%	58%	58%
20	36%	37%	39%	39%	41%	43%	54%	58%	55%
25	35%	37%	37%	37%	39%	40%	51%	55%	52%
30	34%	36%	37%	36%	38%	38%	49%	53%	50%
35	34%	36%	37%	36%	38%	39%	48%	51%	49%
40	34%	36%	37%	35%	38%	39%	47%	49%	47%
45	34%	37%	37%	36%	38%	40%	47%	49%	47%
50	34%	37%	37%	36%	38%	40%	47%	48%	46%
55	35%	37%	37%	36%	38%	40%	46%	48%	46%
60	35%	37%	37%	36%	38%	40%	46%	48%	46%
Avg	36%			38%			49%

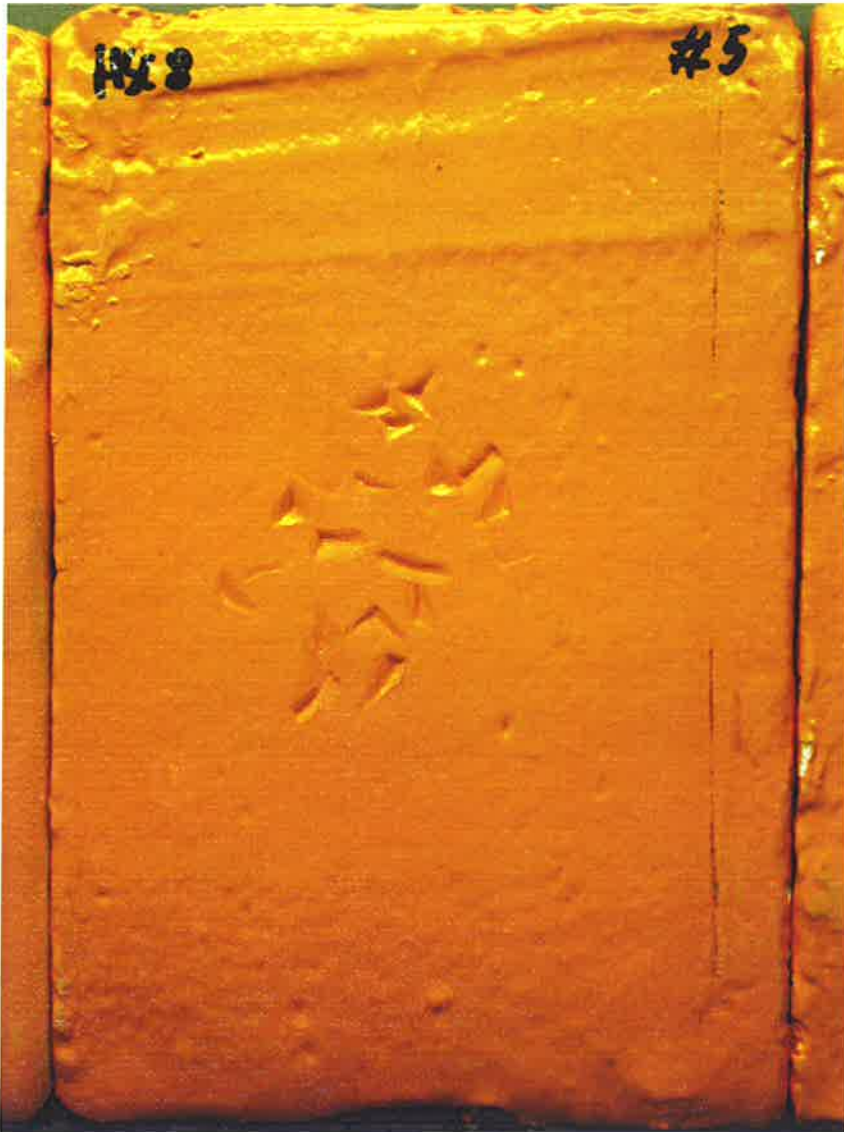
Photo 1. Panel of coating system 3a (8 mm isolation) after Impact Resistance test.

The results after impact testing are the same for all samples. There is cracking in the top layer but no defects up to the steel surface. Some photographs are presented in Annex III.

All coating systems (COT sample number 12-09-11/0606) show a good impact resistance.

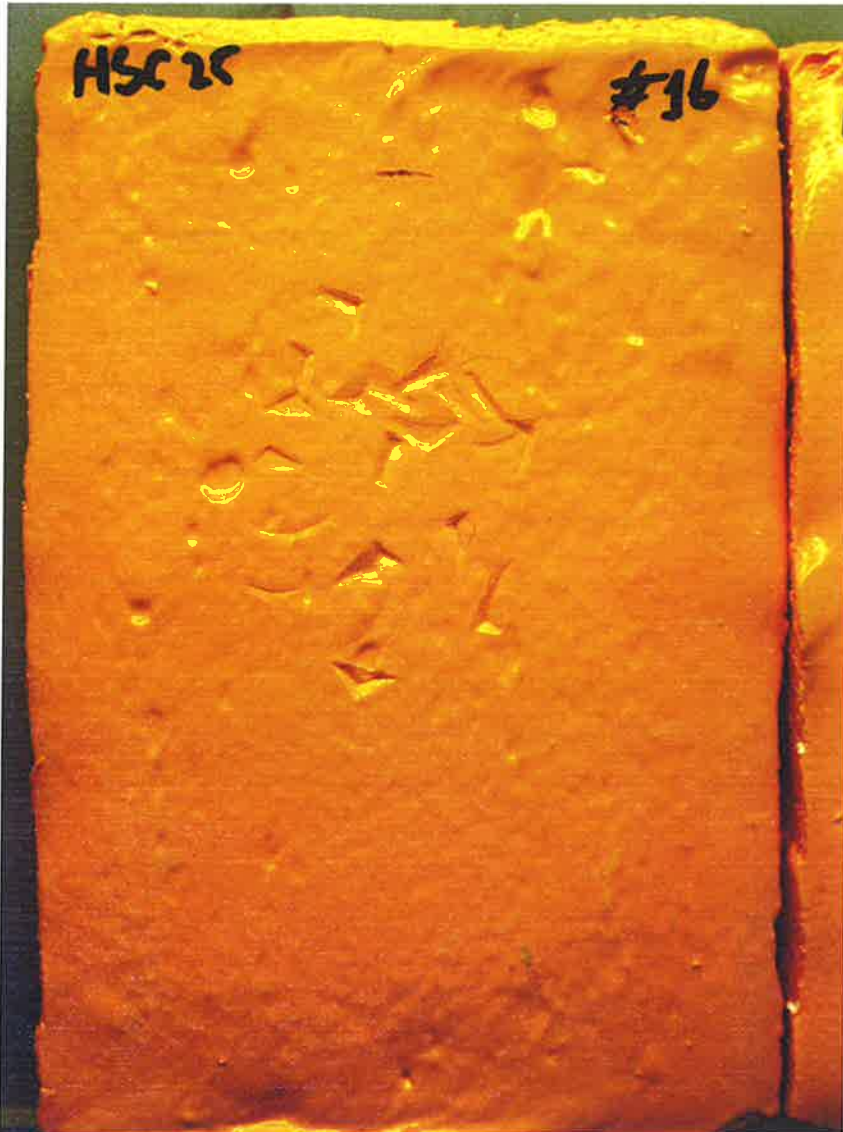
Photo 3. Panel of coating system 3c (25 mm isolation) after Impact Resistance test.
