Reference Chevron Petrol Indonesia

Problem Definition

Project Description

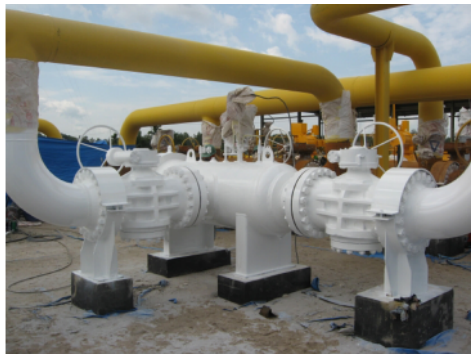
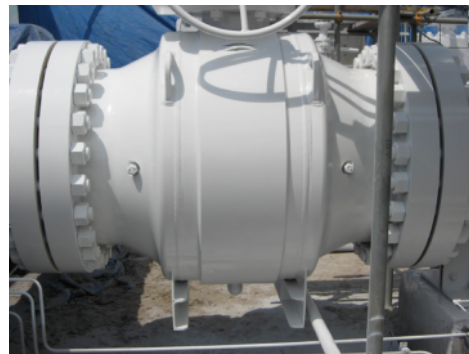
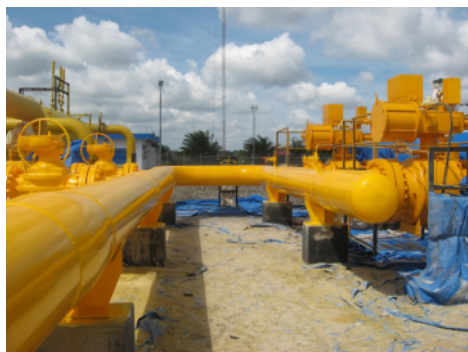
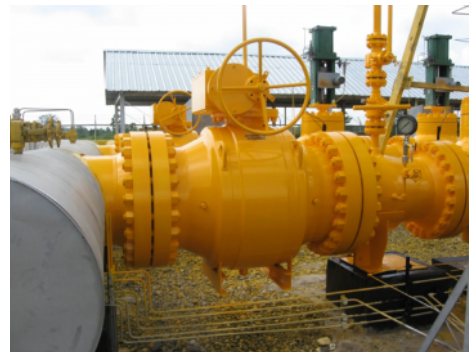
Pictures:

A condensed gas pipeline needed maintenance. It was effected by corrosion. Due to the cold gas running through the pipe and the humid environment the pipe line was constantly condensed, which made conventional paints unusefull.

After sandblasting the pipeline, the old material and rust was removed. To tackle the condensation issue Moist Metal Grip was used as a base coat. For safety reasons the Moist Metal Grip was then coated with yellow tinted EnamoGrip. The trial was done at the pumping station. Treatment of the entire pipeline is discussed and might proceed in 2009/2010. The results were extremely satisfying and no other products performed so well in the Tender. A big advantage was the application could be done online. Please contact us for more information or pictures.

After application, all treated surfaces are smooth, free of rust and dirt and appear as if they are new. The corrosion process has been stopped and surfaces are not being affected by sunlight, dirt and humidity anymore.
