# References SC2 Trading

## References SC2 Trading

### Reference Chevron Petrol Indonesia

## Reference Mobile Phone Container

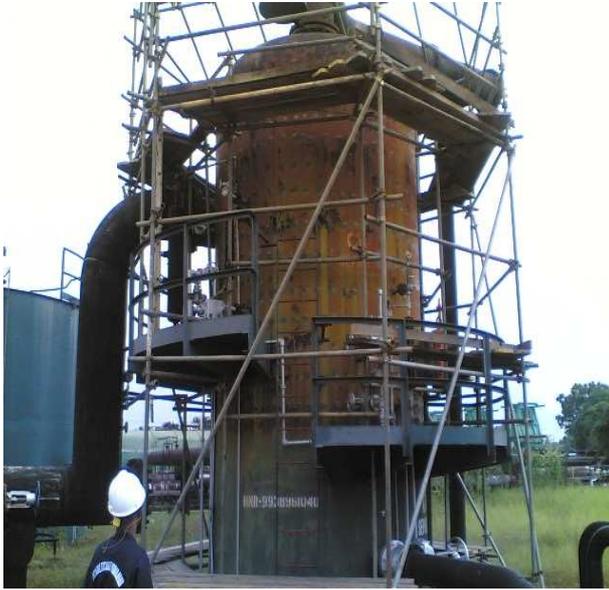
*Before application*

Chevron is facing various problems at one of their oil- and gas refinery locations in Indonesia. Due to high temperatures, high humidity and lack of consistent maintenance, most of the pipelines and storage tanks are affected by corrosion problems.

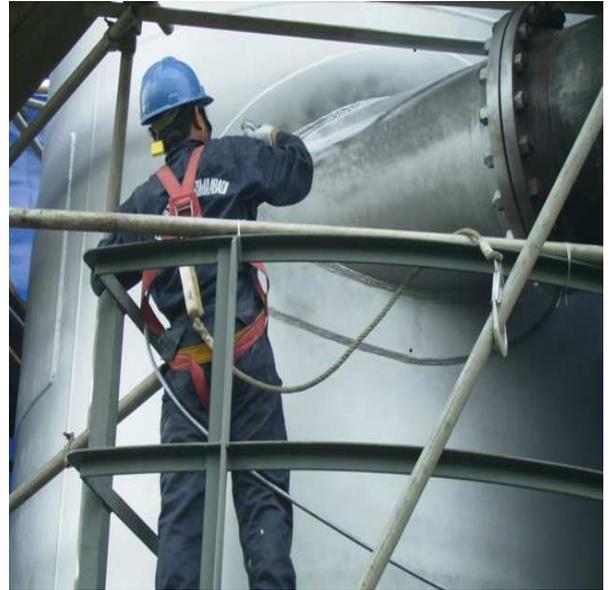
*RustGrip (1<sup>st</sup> layer)*

Clean all surfaces, coat with Rustgrip and use Enamogrip as top layer. Rustgrip will attach on the surface and stop further corrosion problems. Enamogrip gives a smooth and durable finish, which prevents moisture, sunlight and dirt to affect the surface.

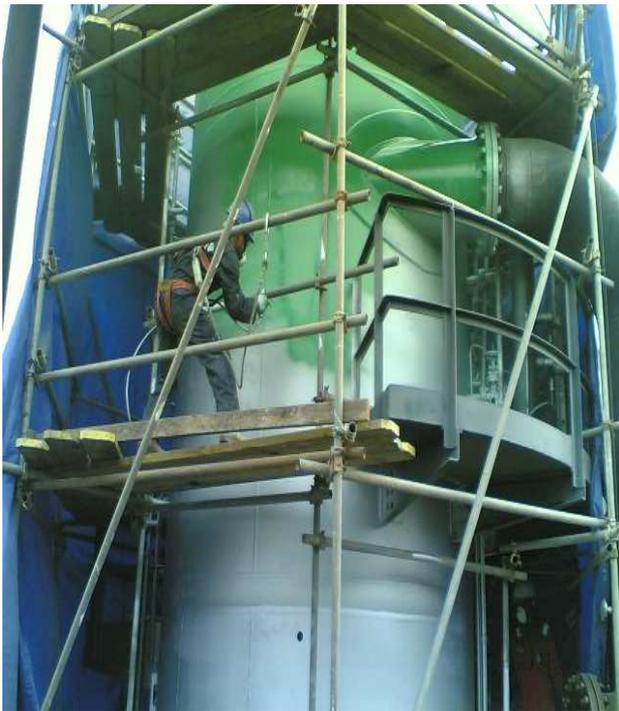
*EnamoGrip (2<sup>nd</sup> layer)*

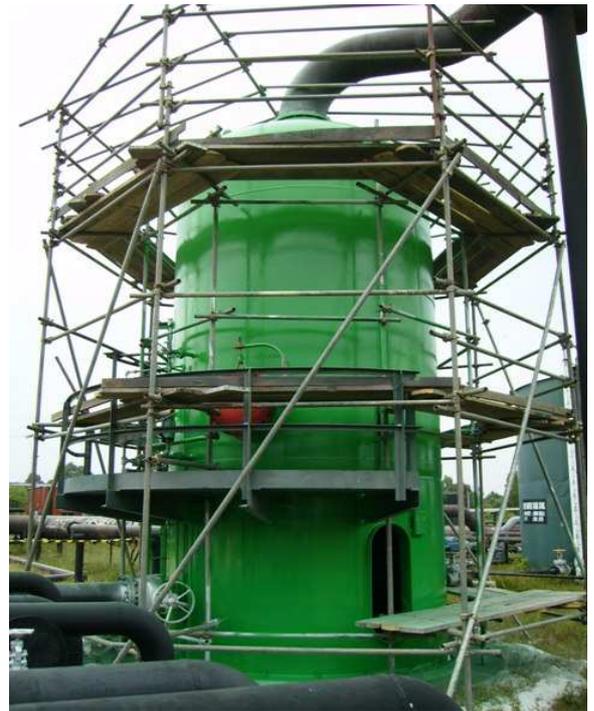
*After applying RustGrip and EnamoGrip*

After application, all treated surfaces are smooth, free of rust and dirt and appear as if they are new. The corrosion process has been stopped and surfaces are not being affected by sunlight, dirt and humidity anymore. Production process is back in full operation now.

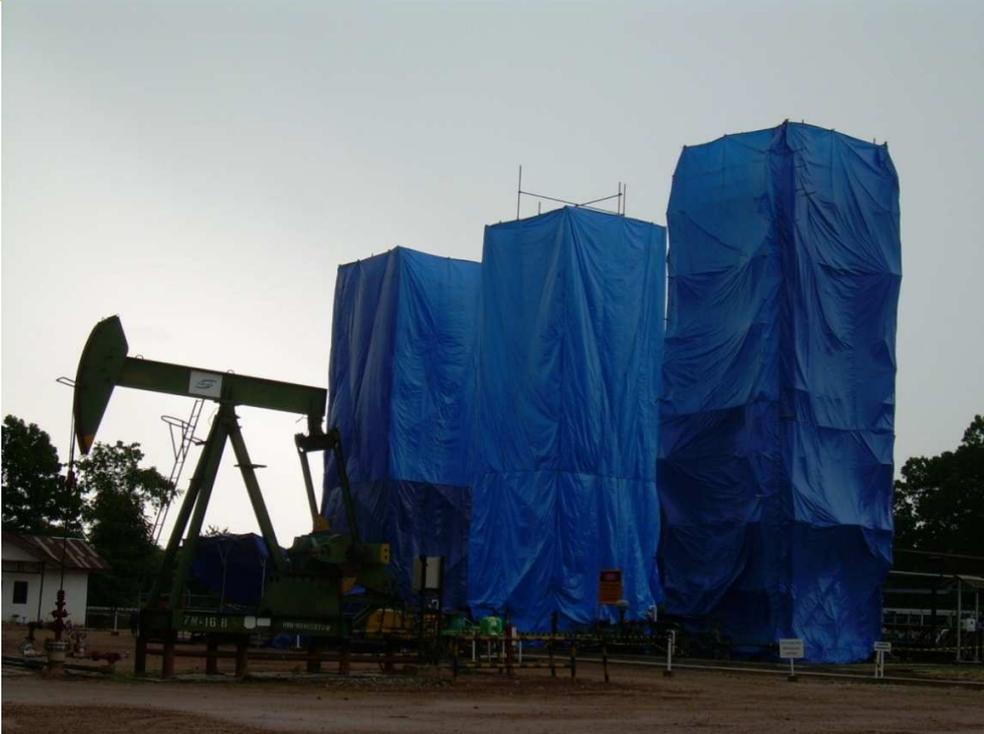
*Oil storage tanks treated with RustGrip and Black EnamoGrip.*

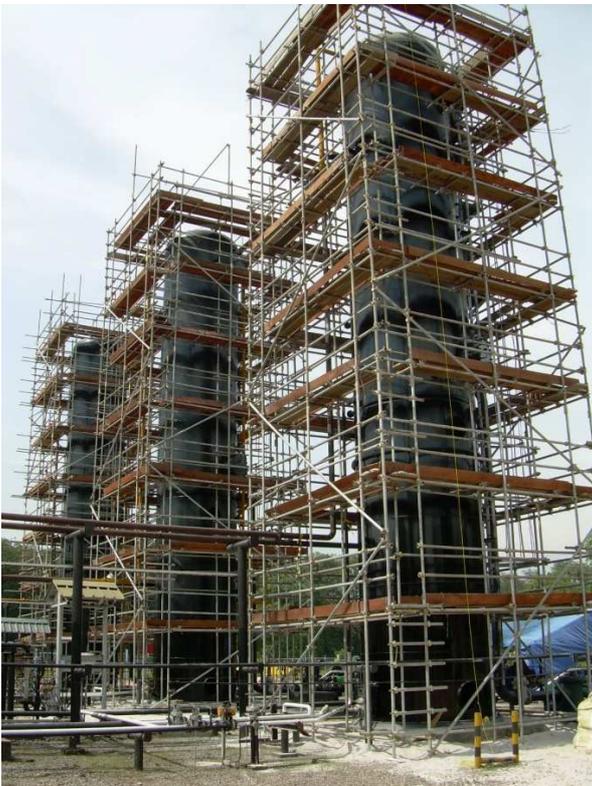
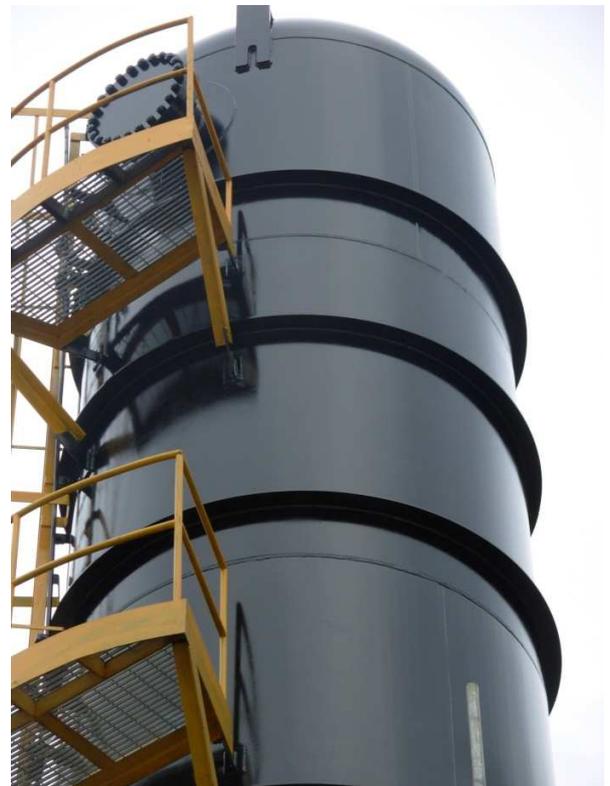
*Close-up of oil-storage tank after application*

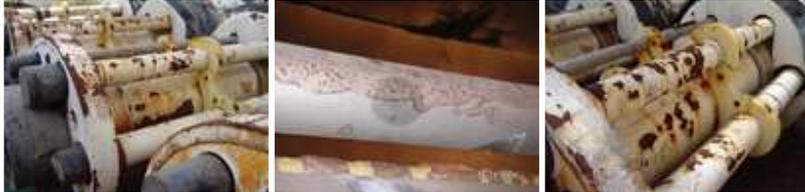
**Anti-corrosion system (RustGrip, MoistMetalGrip and Enamogrip) applied on underwater pipelines:**

Before application:

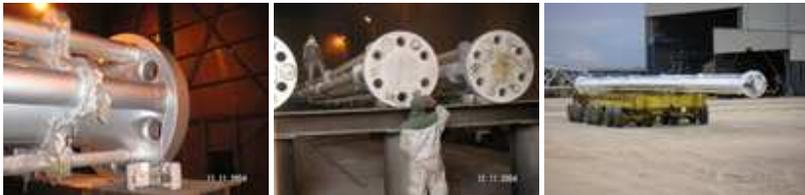
After application:
