HOT PIPE COATING AT VANCOUVER SHIPYARDS

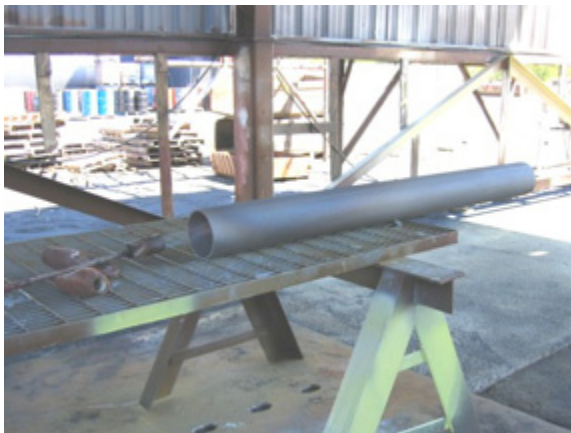
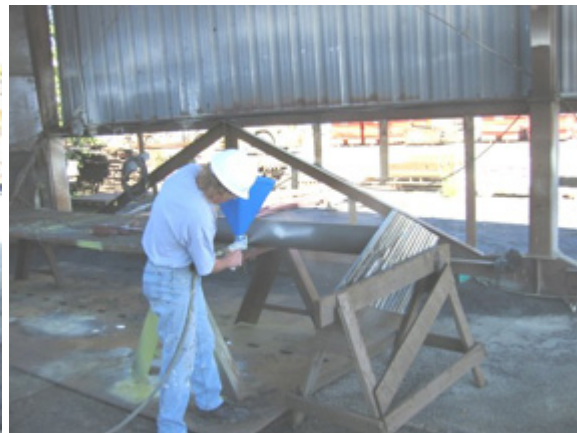
A piece of 8 " Schedule 40 pipe was preheated with a Tiger Torch.

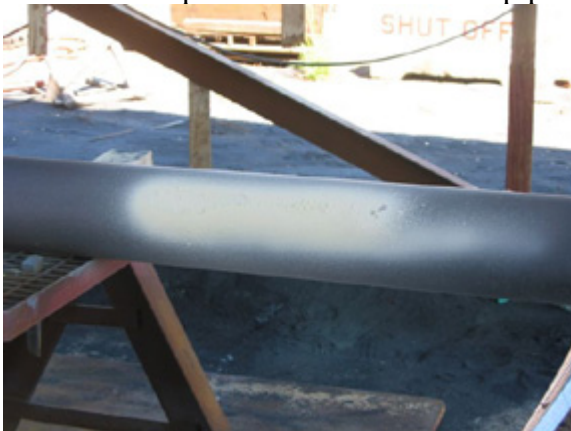
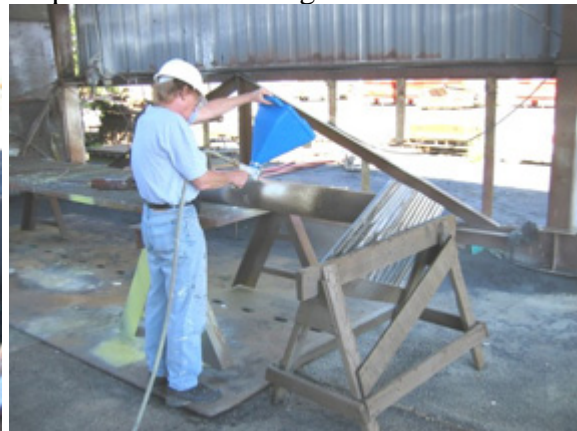
A temperature reduction from **350C** on the bare pipe to **170C** after the initial primer coat @ 50 mils DFT was applied.

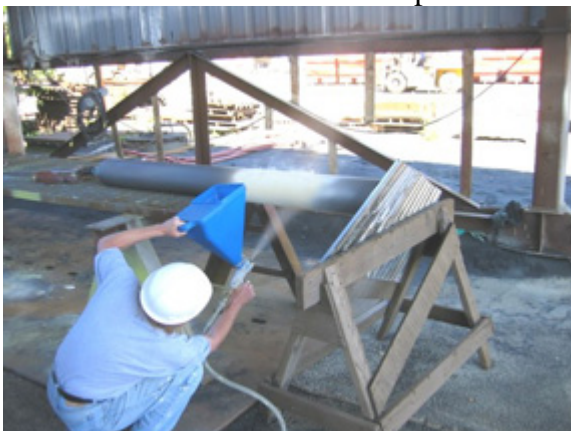
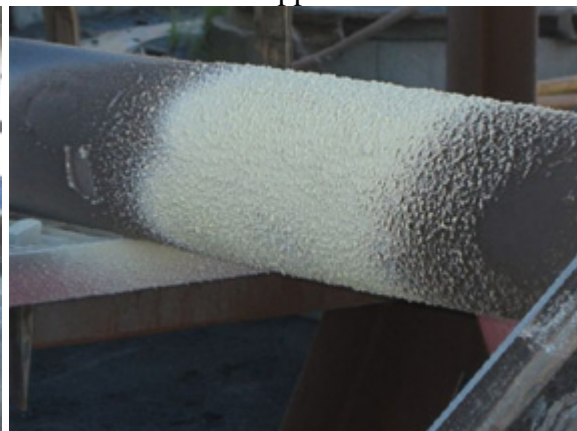
A temperature reduction from **370C** on the bare pipe to **90C** after the second primer coat @ 50 mils DFT was applied. (Video)

Note : This video was taken after the second primer coat of approximately 50 mils DFT and before it had finished steaming off to complete its cure down. This video is courtesy of Doug Robinson, the Health and Safety Officer at Vancouver Shipyards.

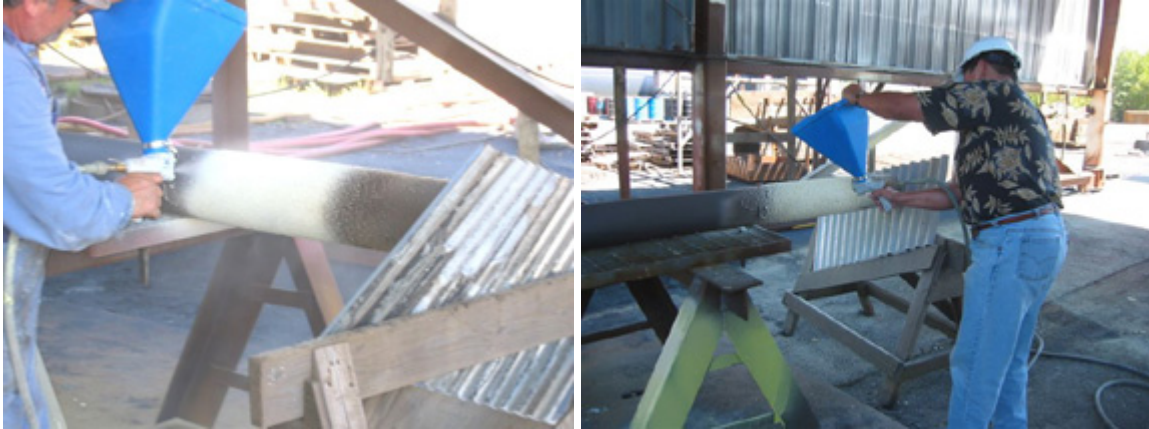
A temperature reduction from **395C** on the bare pipe to **55C** after the build coat @ 100 mils DFT was applied.

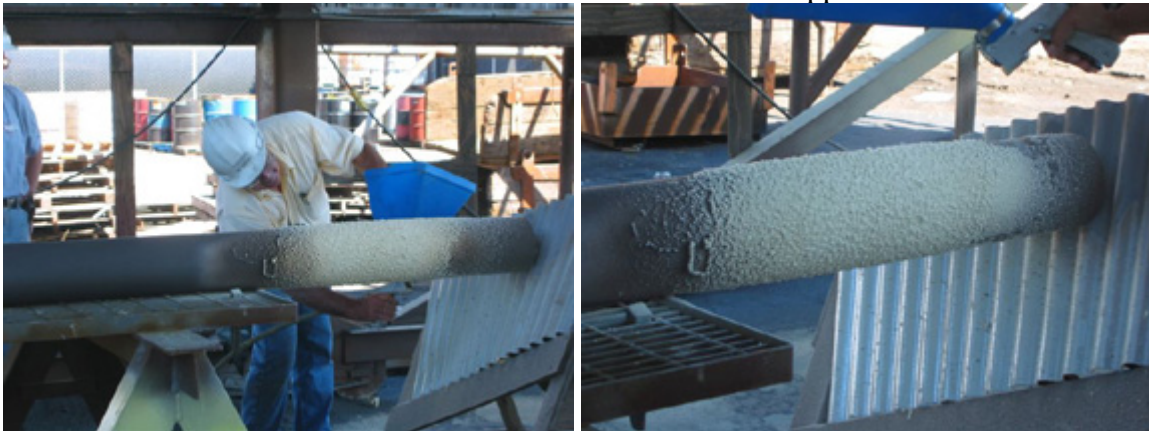
A temperature reduction from **400C** on the bare pipe to **50C** after the final build coat @ 250 mils DFT **TOTAL** was applied.
